# Duxbury Beach Crossover 1 & 2 Dune Restoration

**Project Summary:** Duxbury Beach Reservation, Inc. has a long and successful history of maintaining Duxbury Beach, including extensive dune restoration. Working with the Woods Hole Group, the Reservation identified the area between the first and second crossovers of Duxbury Beach as very vulnerable due to its narrow width and the high wave energy. The living shoreline approach provides erosion control, buffers storm surge, and protects critical habitat for wildlife. The Reservation received a \$500,000 Coastal Resilience Grant through the MA Office of Coastal Zone Management to contribute to the \$1.4 million project. This project represents a portion of the resilience work needed and is a step towards implementing a larger-scale dune nourishment project that will provide longer term health and resilience to the beach. This work bolsters the ability of the beach to protect the communities behind it, particularly in the face of sea level rise and increased storm impacts.

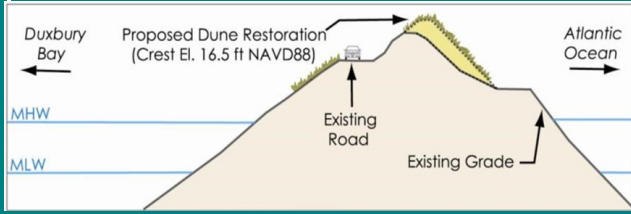
Proposed dune restoration shown in yellow

Impacts Expected from 50 Year Storm  
(solid line represents post-storm grade)

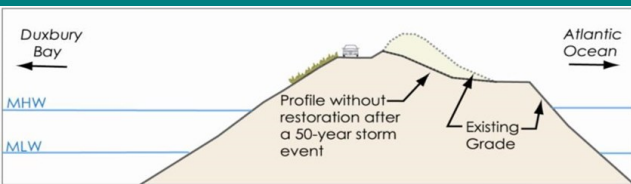
Erosion expected WITHOUT the proposed project.

- Dune is destroyed
- Beach is overwashed

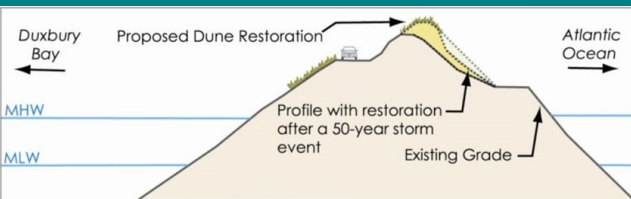
Erosion expected WITH the proposed project.

- Dune provides increased protection
- Beach is not overwashed

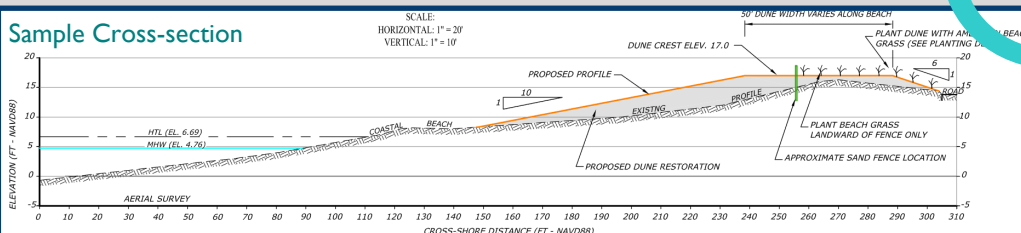
## Sample Cross-section

Wave energy modeling by the Woods Hole Group shows that the area between First and Second Crossovers suffers higher wave energy than other areas of the beach.
